## Aviation Safety

# Maintainer

Issue 3/2003

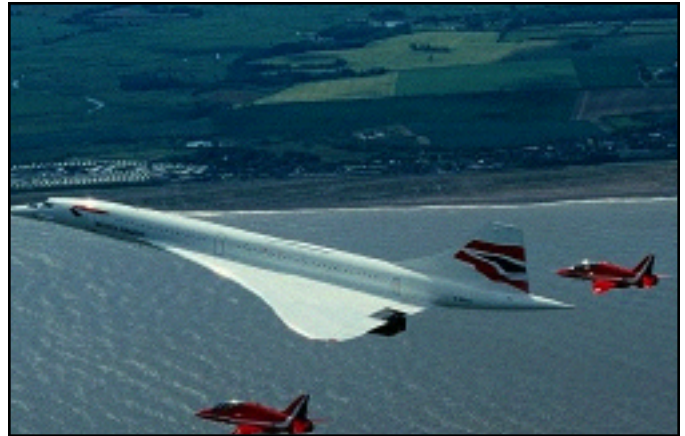
The Concorde took off on a flight from Paris, France to New York, USA, on July 25, 2000. During the take-off roll, and just before rotation, a front right landing gear tire ran over a strip of metal and was damaged. It burst into several pieces and debris was projected against the left wing fuel tank No. 5 outboard skin, which ruptured and sent fuel that ignited immediately as it came in contact with hot exhaust gases from the engines. The No. 1 and No. 2 engines lost power and No. 2 was shut down. The No. 1 engine was operated briefly at idle power due to a fire warning alarm, and the aircraft took off as it was too far into its take-off run. The landing gear would not retract because of hydraulics failure and the aircraft could not gain height or speed. It flew for about 1 min when the No. 1 engine lost power, the angle of attack and angle of bank increased, the No. 3 and No. 4 engines lost power and the Concorde, uncontrollable at this point was lost.

The French civil aviation investigation bureau, the *Bureau d'enquêtes et d'analyses pour la sécurité de l'aviation civile* (BEA), found that during the take-off phase, the tire on wheel No. 2 was cut by a metallic strip on the runway. The part came from the thrust reverser cowl door of engine No. 3 on a DC-10 that had taken off 5 min before the Concorde. It had been replaced twice in the last two months; once in June and once in July of 2000. The second time that it was replaced, it had neither been manufactured nor installed in accordance with procedures defined by the manufacturer. "The loss of the wear strip from the thrust reverser door on the Continental Airlines DC-10 originated from a lack of rigorous maintenance. The part was not in accordance with the manufacturers specifications. Of course, this is not a critical part from an airworthiness perspective, but true safety implies strict respect for procedures, without any personal interpretation. Facts established concerning the metallic strip and the aircraft reveal inadequate adherence to maintenance procedures by the various workshops that carried out the work on the reverse cowl." (BEA)

In order to return the Concorde to service, the BEA recommended that a flexible fuel tank liner be installed to reduce the risk of fuel leak following damage, and the possibility of a shock wave that

could induce fuel instability and fuel tank rupture. It also recommended the installation of new reinforced Michelin tires that would have improved impact resistance qualities. There were modifications made to the landing gear water deflectors and reinforcements made to the wiring of the main undercarriage area. It further recommended that operators adopt a feedback process, SMS\*, that would provide through analysis of in-service accidents, a process to identify and rectify safety issues before they could ever become an accident with tragic consequences. Several Concorde had sustained tire failures, and fuel tank damage due to impact from tire or foreign object damage (FOD) debris prior to July 25, 2000.

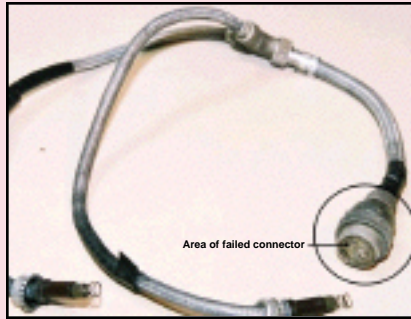
A float-equipped DHC-2 was cruising at an altitude of 1 500 ft enroute from Campbell River, B.C. when the engine failed and would not restart. The

pilot set the aircraft up for a glide and proceeded to land uneventfully close to a marina near Seymour Narrows, B.C. The aircraft was soon towed to a safe moorage where the pilot and passengers were able to exit the plane and return home. Close examination of the engine revealed that the engine stoppage was due to a failure of the dual magneto cable connector lug at the firewall. This part, identified as SKL3-21-3-8AN, has an internal safety mechanism that disables both magnetos to preclude inadvertent start of the engine when the magneto electrical harness is disconnected from the firewall for maintenance.

When the unit functions properly and the lug is connected, a male mating pin lifts a shorting strap out of the way and removes the ground from the magneto “P” leads, allowing control of the magnetos through the cockpit magneto selector switch. If this pin fails, it may allow the shorting strap to ground the mags and the engine malfunctions. This type of

connector receptacle only seems to be common to the DHC-2 and -3. The connector is an “on condition” component and as it ages, the risk for malfunction increases. There is no practical test to determine its condition. Aircraft maintenance engineers (AME) working on these types of aircraft may not be aware of the presence of such a mechanism and may find, through a continuity check that the magneto leads are all right when in fact, this grounding strap may be about to fail. The maintenance manuals for both of these aircraft as well as the Service Bulletin and Service Letter index make no mention of such unit maintenance requirements as they are operated to failure, then replaced.

In another similar case of engine failure, the Otter engine failed because the magneto connector lug at the firewall loosened and let go, allowing the internal connector grounding strap to function and stop the engine. Investigation revealed that the magneto connector lug secured by a lock wire had failed because the lug collar hole had broken open and allowed the lock wire to slip away and the connector to become undone. De Havilland Alert Service Letter A2/53 makes reference to this mode of failure and a check of the state of these important features on the connector lugs will prevent the reoccurrence of such mishaps. Bombardier/DeHavilland, recommends that this inspection be carried out at the earliest opportunity. Beware! 🛠️
